Berwick Breakwater Refurbishment, Berwick Upon Tweed, UK

This paper describes the development of a complex scheme for the refurbishment of this historic structure in a historic and environmentally sensitive location with limited access. It shows the successful approach used for the generating the repair strategy, repair design and final implementation of the works to a finite budget.

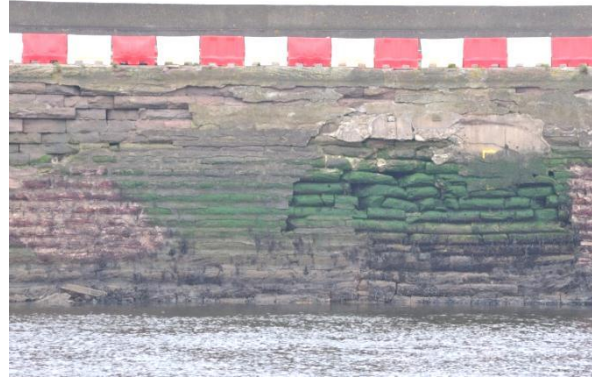
The principal defects identified through the regular programme of inspections were:-

- Significant cracking, spalling and abrasion of mass concrete;
- Plucking of facing stones;
- Washout of mortar, (see figure 3);
- Developments of voids within the core (see figure 3), with air and sea water being compressed and forced through cracks in concrete and masonry;
- Undercutting of the base along approximately 70% of the length of its estuary-facing side, in places by up to 1m but more typically by around 0.5–0.7m;
- Break-up of some previous repairs and strengthening works;
- Vegetation growth in joints.

Figure 3 – Damage to Southern Stone Face

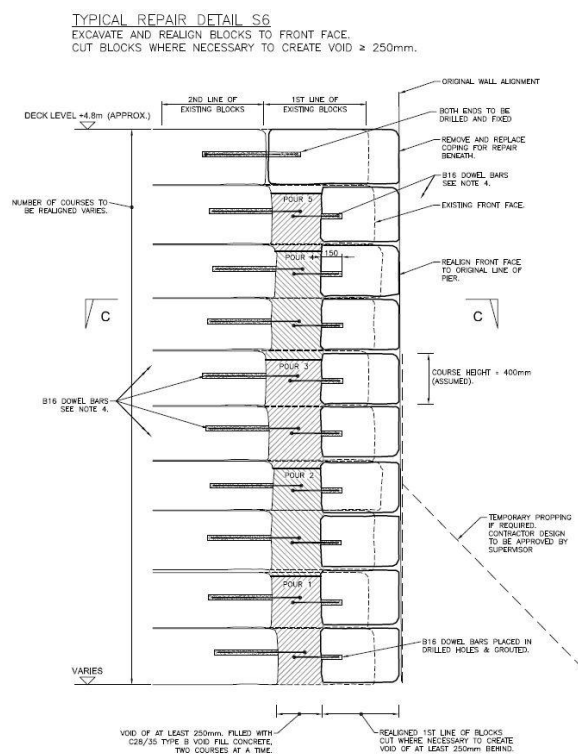
Figure 4 – Stone Face Repair Detail

The approach of the stone face design was to reuse as much of the existing stone blocks from the structure as possible or salvage from adjacent to the foreshore, if possible. Previous investigations had identified that the stone blocks in the structure were of a considerable size (1-1.5 m deep from the face). Whilst much of the stone was thought to have deteriorated, significant quantities of blocks were still intact and with adequate strength to be reused. These blocks were cut into smaller pieces in depth and were used as facing blocks to the outer extremity. The voids left behind the face were then filled with concrete which was tied to the face blocks using anchors (as seen in Figure 4 adjacent). This aided in minimising the quantities of new stone required for the scheme.

In considering the conservation value of the structure, the approach to the concrete facing repairs was viewed to return some of the aesthetic nature of the original stone to the pier face whilst improving the durability of the surface material. This was achieved by removing the damaged concrete facing from the structure and replacing with a new reinforced concrete face tied into the body of the structure. The concrete appearance was enhanced by use of pigmented concrete to match the natural colour of the original stone, and by addition of patterned formliner finishes to give the appearance of natural stone work repairs to the face. This was agreed with the County Conservation Officer.

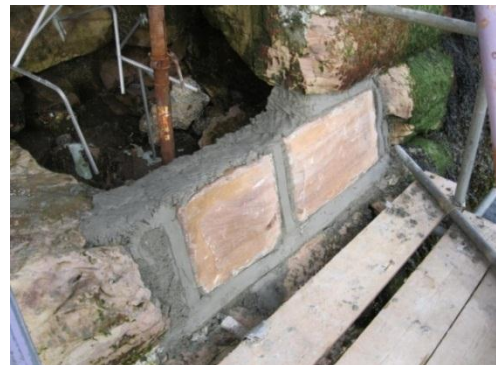
Figure 8 – Blockwork repair mid structure

The localised areas of existing stone was lifted out of the structure and placed on the deck. Stonemasons then assessed the condition of the blocks for existing faults/ fissures and determined which blocks could be cut and redressed to form replacement blocks with a minimum depth. Limited quantities of new stone were ordered from the approved local quarry to make up the shortfall. Anchors were drilled and fixed into the back of the blocks prior to lifting back into position. Mechanical anchors were drilled and fixed into each block to allow a lifting eye to be attached in order to lift the blocks into the repair area. All blocks were pointed using a mortar containing an accelerant to ensure it would set prior to being covered by the tide. Figure 8 shows a typical stone repair.

The blockwork and compacted concrete backfill was placed in lifts of a maximum of two courses of blockwork to maintain stability. Initial attempts using grout fill were abandoned after it was found to run through the voids in the structure. So visible gaps in the recess were pointed prior to block placement and concrete fill to the top course was placed via a letter box in the stone face. This ensured the void space was filled and compacted.

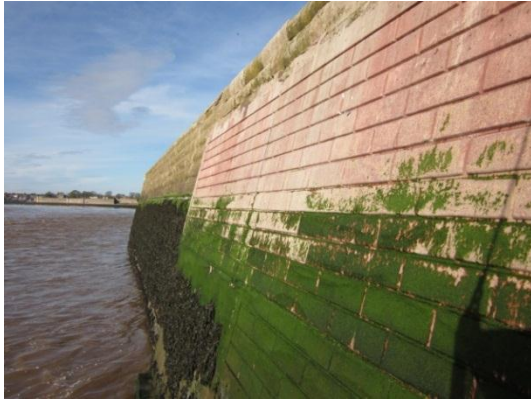
Figure 9 – Reinforced Concrete Repair

The reinforced concrete repairs totalled an area of approximately 130m² in two locations along the southern face, Figure 9 below shows one of these areas. These repairs spanned above and below mean high water level and consequently were carefully programmed to coincide with spring tides to maximise construction time at the lower levels of the repair area. Where spring tide did not provide an ample working window, a diving subcontractor was used to assist in the installation of reinforcement, shutters and concrete. The defective concrete patch repairs were removed using either a breaker or rock wheel attached to the wheeled excavator.

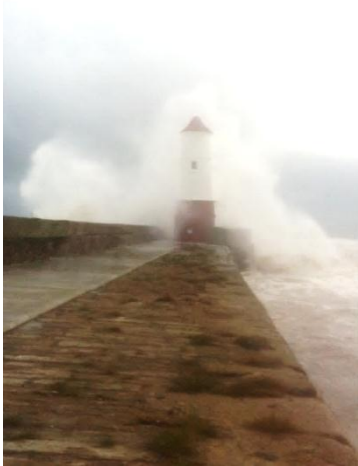
Figure 11 – Breakwater battling the elements

Whilst initial progress on site was good following the removal of the electric cable, the repair works became increasingly affected by weather, river flow, and sea state. High winds prevented lifting operations, large swells and high river flow prevented divers entering the water and waves washing over the structure (Figure 11) prevented access to the breakwater on a couple of occasions. All these events caused prolonged delays to the works and moved the 2011 demobilisation date back into December. This required an extension to the Natural England Assent to remain on site to try and close open repair areas in order to safeguard the structural stability of the breakwater during the further winter months.
