Berwick Breakwater Refurbishment, Berwick Upon Tweed, UK

This paper describes the development of a complex scheme for the refurbishment of this historic structure in a historic and environmentally sensitive location with limited access. It shows the successful approach used for the generating the repair strategy, repair design and final implementation of the works to a finite budget.

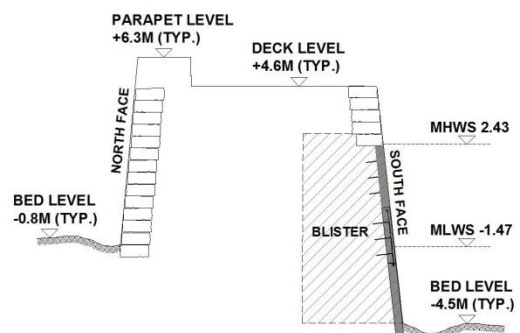
Figure 2 – Breakwater Cross Section

The breakwater consists of stone masonry walls and block in-fill within the core. A parapet wall is located along the seaward length of the structure on its crest to reduce wave overtopping. Figure 2 shows the typical cross section through the breakwater. A roundhead, strengthened by a buttress wall, has been formed at the distal end. Much of the breakwater dries out on an ordinary spring tide on its northern face, but is usually submerged at its toe on its southern face where it abuts

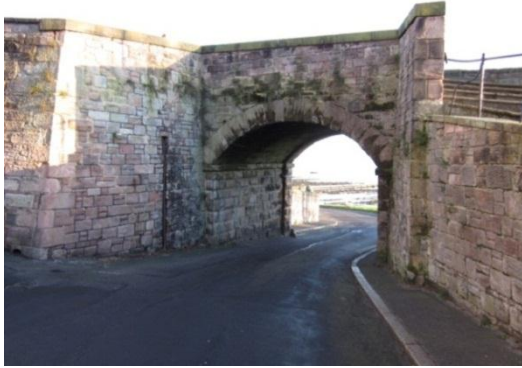
Figure 5 – Ness Arch

The restrictions on access to the site imposed by Ness Arch, as shown in Figure 5, meant that careful consideration to construction plant was required. Cranes, large excavators and concrete wagons were all too large to pass through the arch. The contractor chose to use 360 degree slewing MerloRotos (small telescopic boom cranes) to position manrider baskets against the face of the breakwater, a 12m telehandler to deliver materials, and 6T dumpers with drop down roll over bars to remove materials that arose from demolition. In order to perform demolition operations and reach the toe of the breakwater, 7m below deck level, a 20T wheel mounted excavator was used. This equipment required alternative access to the breakwater via Berwick Golf

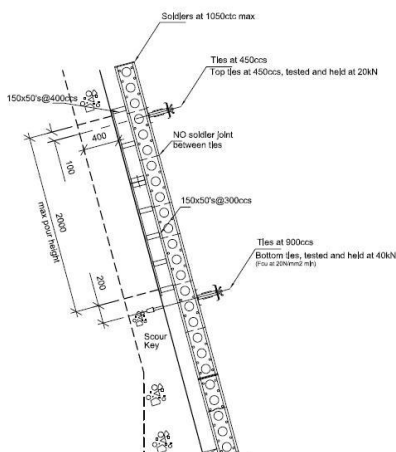
Figure 6 – Shutter Design

All formwork on the scheme was single sided shutters. To accommodate tide works, repairs commenced from the top and bottom of the structure simultaneously. The top concrete pours adopted a single sided soffit shutter cantilevered from deck level, lower pours being a more traditional single sided shutter design tied to the wall. Care had to be taken at design stage to allow for the poor condition of the existing sandstone and low pull out test results (20kN in existing sandstone) achieved from the tie bars, all tie bars were fixed in to the structure with resin and were tested prior to installing the shutter and pouring concrete. The temporary works were designed for formwork forces as these exceeded the environmental loadings. Tie bar loads were the governing factor, which meant primaries were closely spaced with walers spanning along each row of tie bars. (Refer to Figure 6 above)

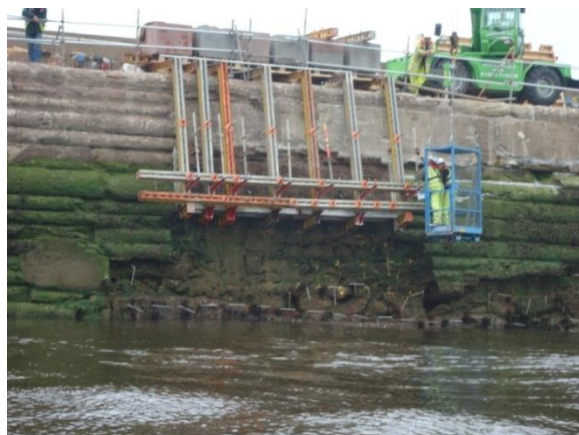
Figure 7 – Manrider Basket Access/ Top shutter Installation

It was initially planned to access the repair areas on the southern and northern faces using scaffold platforms, and manrider baskets suspended from 360 degree slew MerloRotos. However, it soon became apparent that scaffold platforms suspended from the breakwater deck would not withstand the flows from the River Tweed and sea conditions so required daily maintenance to make safe prior to every working shift. The contractor decided to access all the repair areas out of manrider baskets positioned by the MerloRotos under banksman supervision, as shown in Figure 7 below.

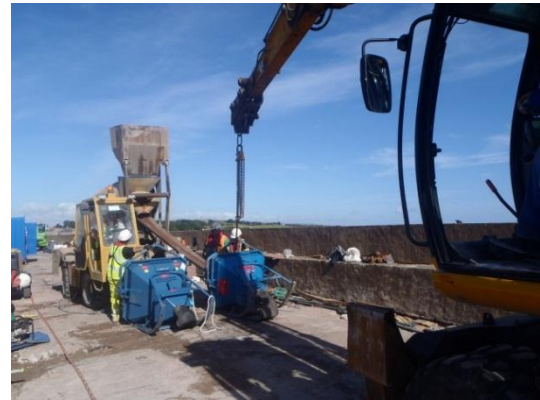
Figure 10 – Concrete Placement

The reinforced concrete repairs totalled an area of approximately 130m² in two locations along the southern face, Figure 9 below shows one of these areas. These repairs spanned above and below mean high water level and consequently were carefully programmed to coincide with spring tides to maximise construction time at the lower levels of the repair area. Where spring tide did not provide an ample working window, a diving subcontractor was used to assist in the installation of reinforcement, shutters and concrete. The defective concrete patch repairs were removed using either a breaker or rock wheel attached to the wheeled excavator.
