DEVELOPMENT OF A 40MW PHOTOVOLTAIC PLANT ACROSS SITES 2B, 3B, 3C, 4B AND 5B ASSOCIATED WITH THE TUBATSE FERROCHROME PLANT, STEELPOORT, FETAKGOMO TUBATSE LOCAL MUNICIPALITY (REF 12/1/9/2-GS88)

Environmental Impact Assessment Report

Client: TFC Solar (Pty) Ltd
LEDET Ref: 12/1/1/9/2-GS88
Document Ref: MD6154-RHD-XX-XX-RP-X-0001
Status: Draft/01
Date: 19 February 2024

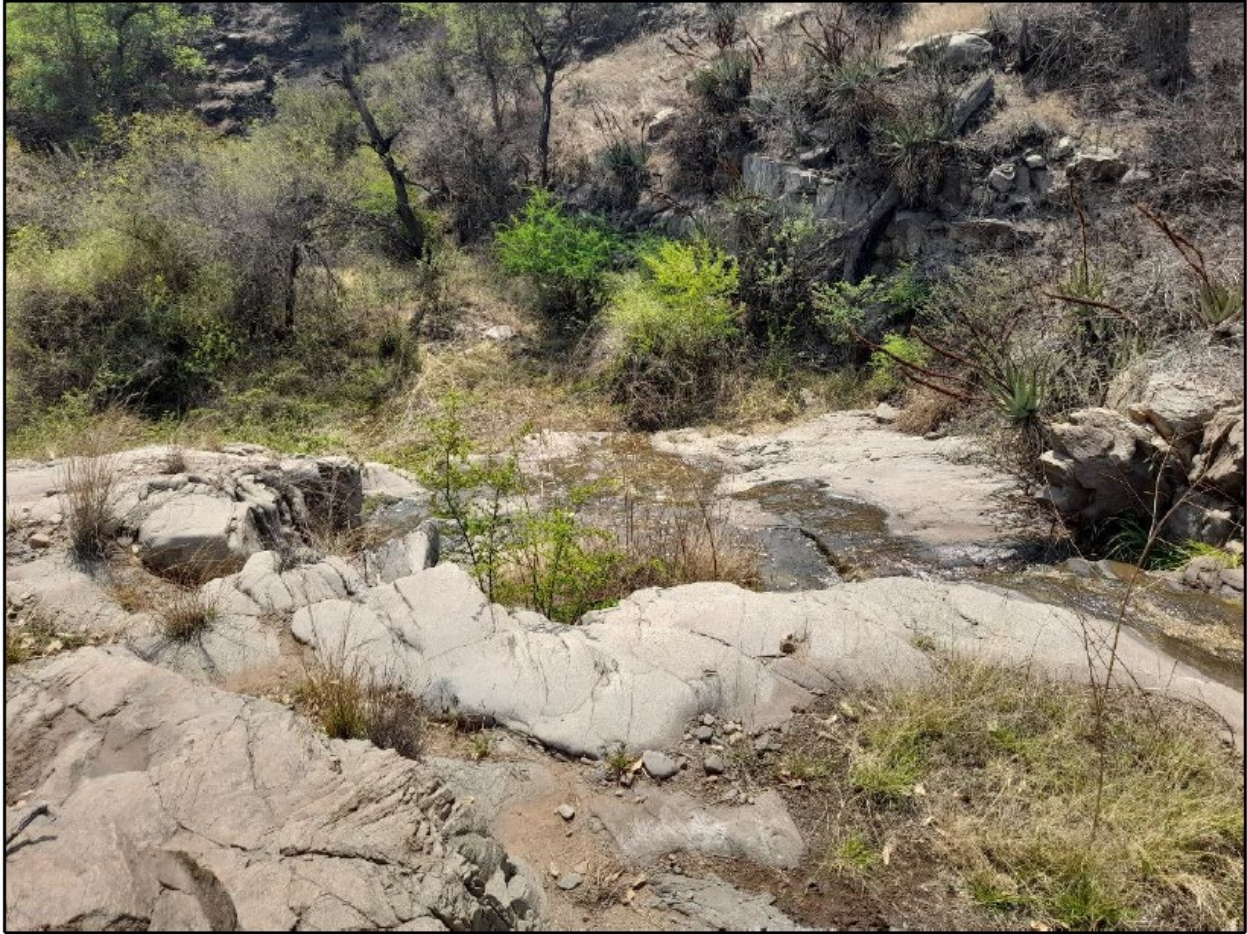
Figure 5-13: A reach of the EDL that runs between Sites 3C and 4B that is characterised by bedrock outcropping in a part of the reach where the terrain drops steeply

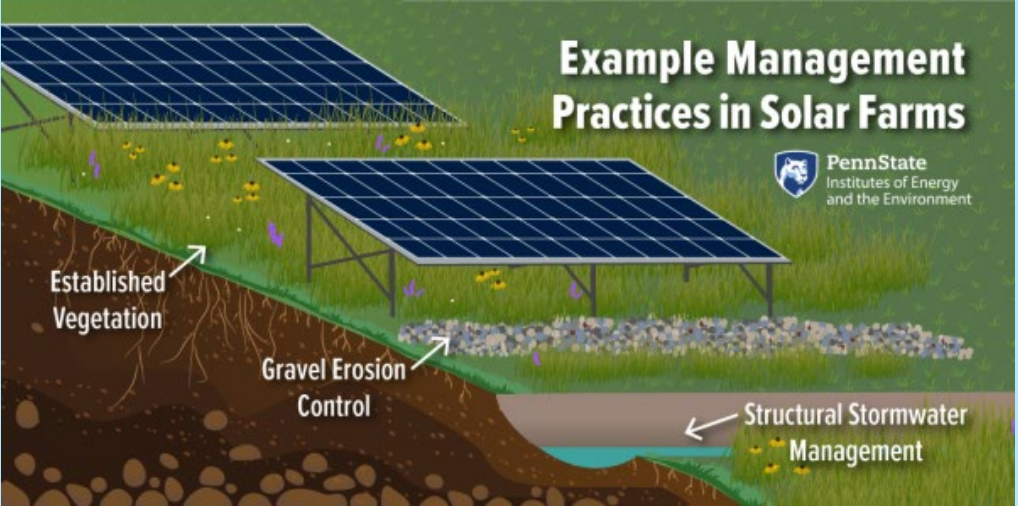
<p>Example Management Practices in Solar Farms</p> <p>PennState Institutes of Energy and the Environment</p> <p>Established Vegetation</p> <p>Gravel Erosion Control</p> <p>Structural Stormwater Management</p> <p><i>Figure 7-5: Concept of gravel erosion control strips (McPhillips, 2023)⁵⁸</i></p>

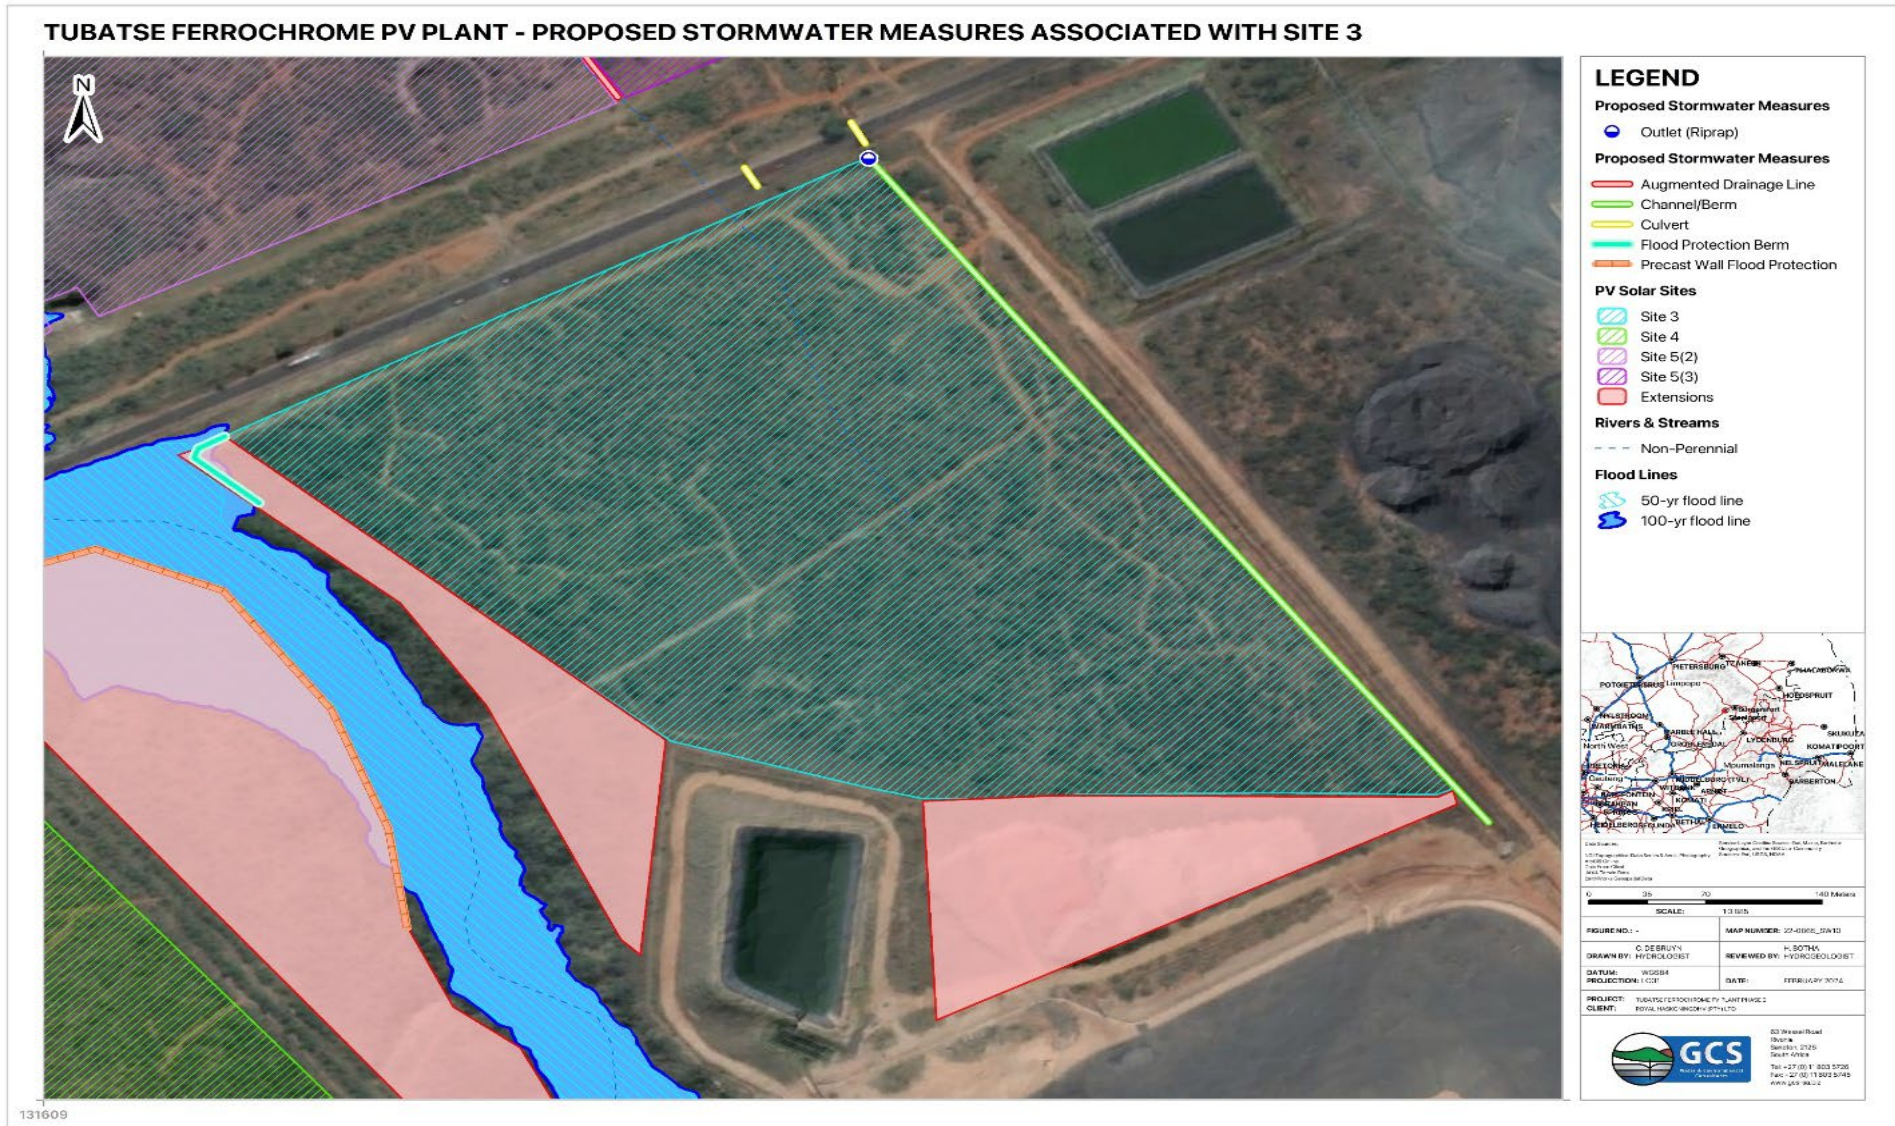
Figure 7-8: Proposed stormwater infrastructure for Site 3 and expansion areas

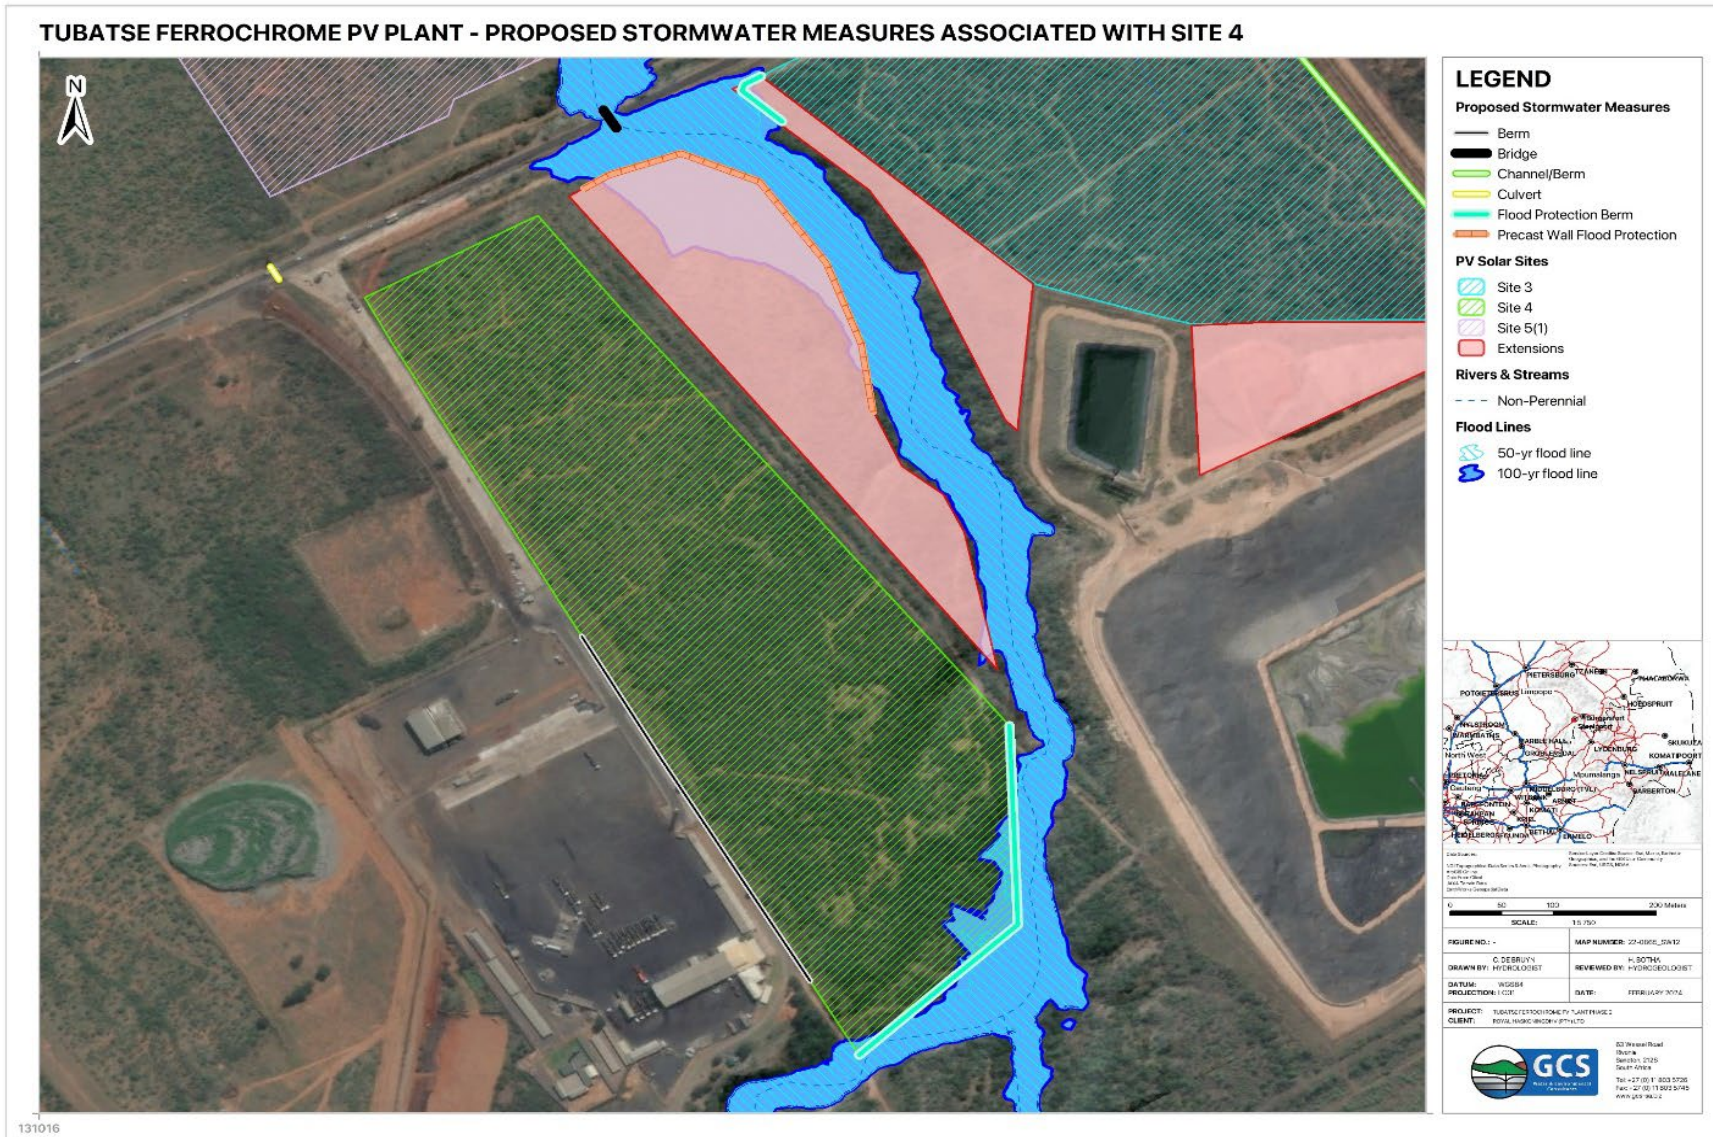
Figure 7-10: Proposed stormwater infrastructure for Site 4 and expansion areas
